## **Measuring Pinhole Leaks – A Novel Method**

**By Carol Dunn**

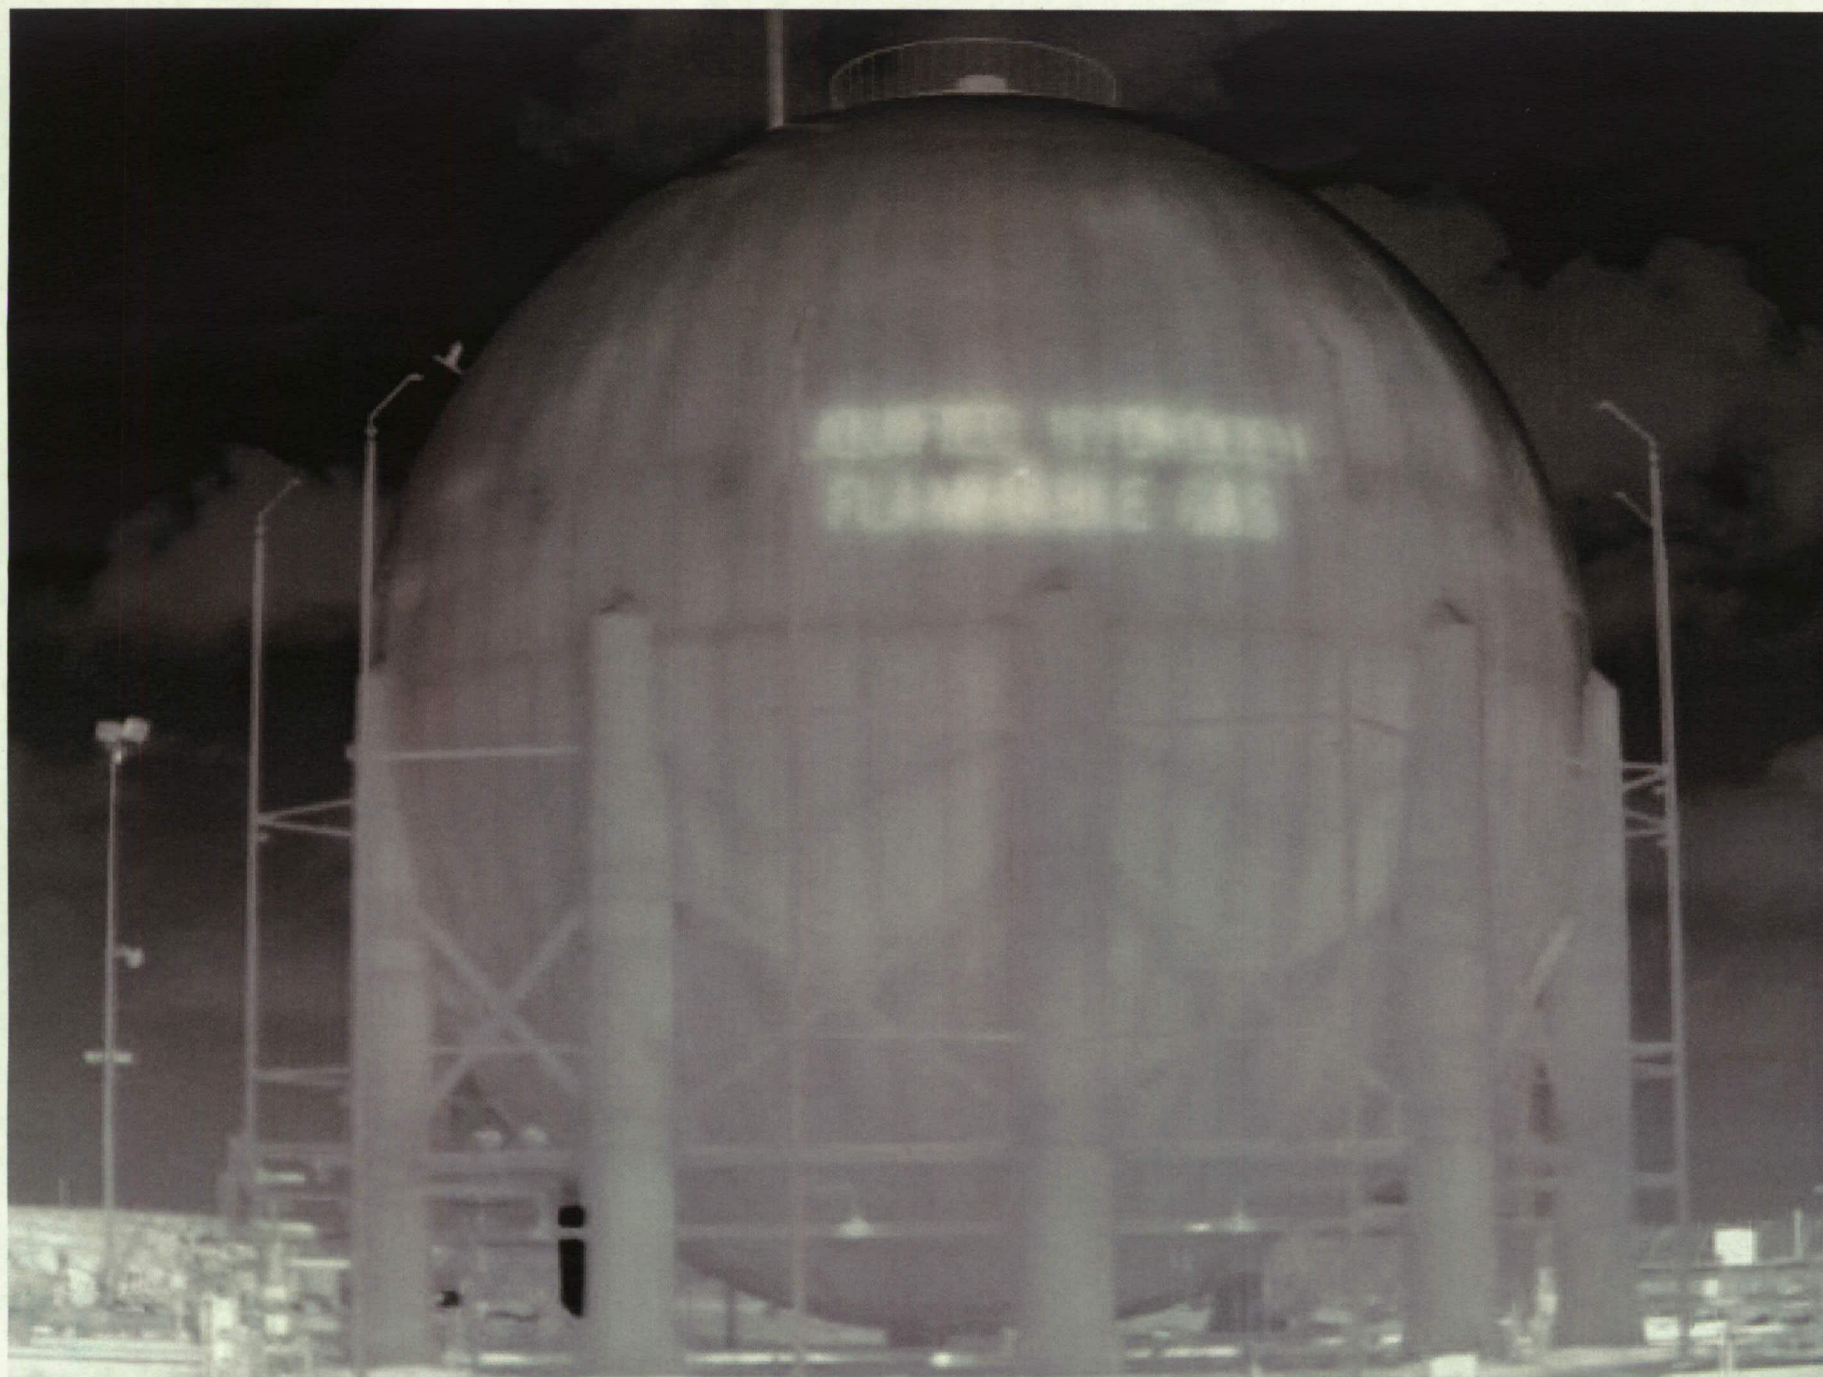
It is interesting to note that the original design for these tanks included a stairwell to be welded to the outside of the tanks. These weld points caused corrosion, and so the stair well was removed. These old corrosion points as well as others are places where pinhole leaks could develop. Another problem is perlite migration, which causes voids between the outer and inner tank. However, analyses, IR imaging, and boil-off data show condensation and increased hydrogen boil off, which all indicate changes that should be looked at by engineers. Without this solution, a pinhole leak could go undetected for months. The potential savings here is in the hundreds of thousands of dollars and could potentially increase the life of the tanks. Constellation will use the existing liquid hydrogen tanks and will need even more liquid hydrogen storage (at least at Pad A), so this concept will be used throughout the program.
